Geotechnical
Environmental and
Water Resources
Engineering

**Specific Site Assessment for
Coal Combustion Waste
Impoundments at Santee
Cooper Grainger Generating
Station**

Conway, South Carolina

July 2010
Project 092881

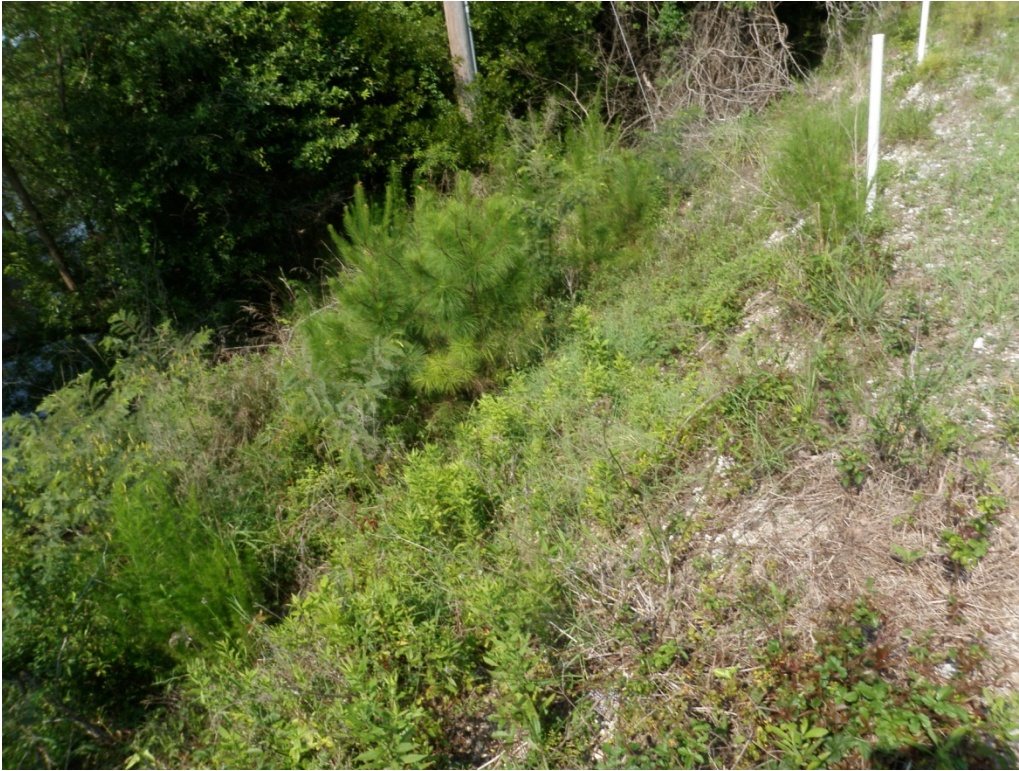
Ash Pond #1 was converted to a dry storage area in 1977, though the dike surrounding the storage area is still in place. We observed the existing dike to generally be in good condition, with no signs of movement, cracking, settling, erosion or deterioration. Trees have been allowed to grow on the downstream slope of the dike since it does not impound wet CCW.

Photo 1 – Ash Pond #1 (dry handling, continually dewatered): Downstream slope.

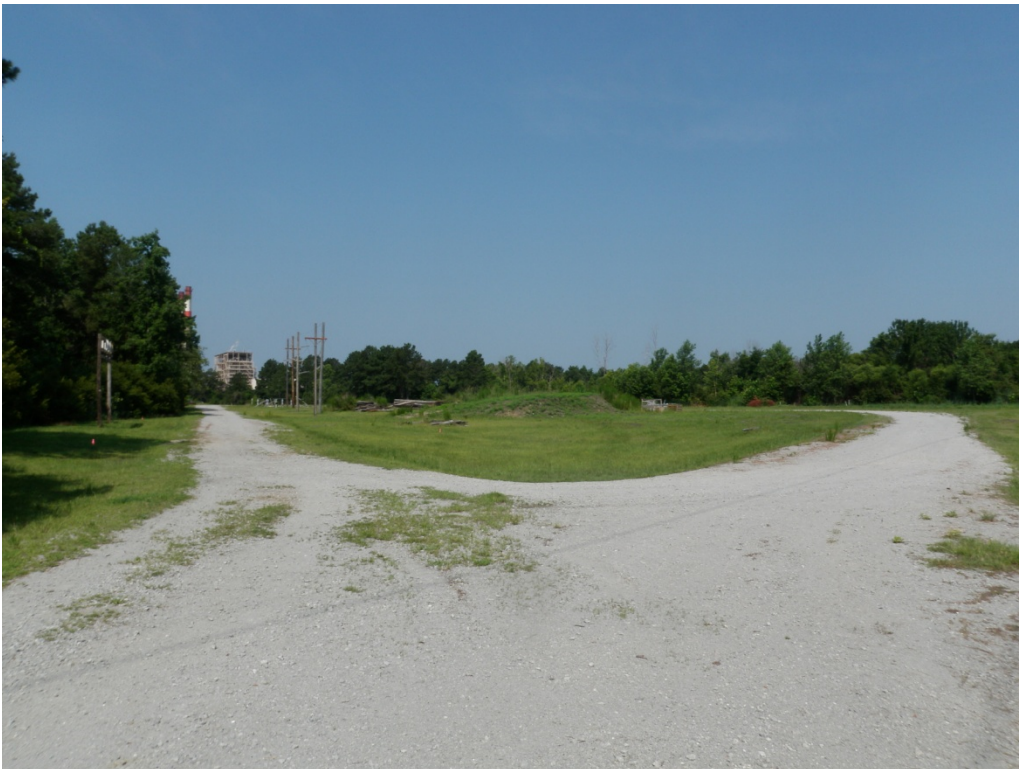
Photo 2 – Ash Pond #1: Overview.

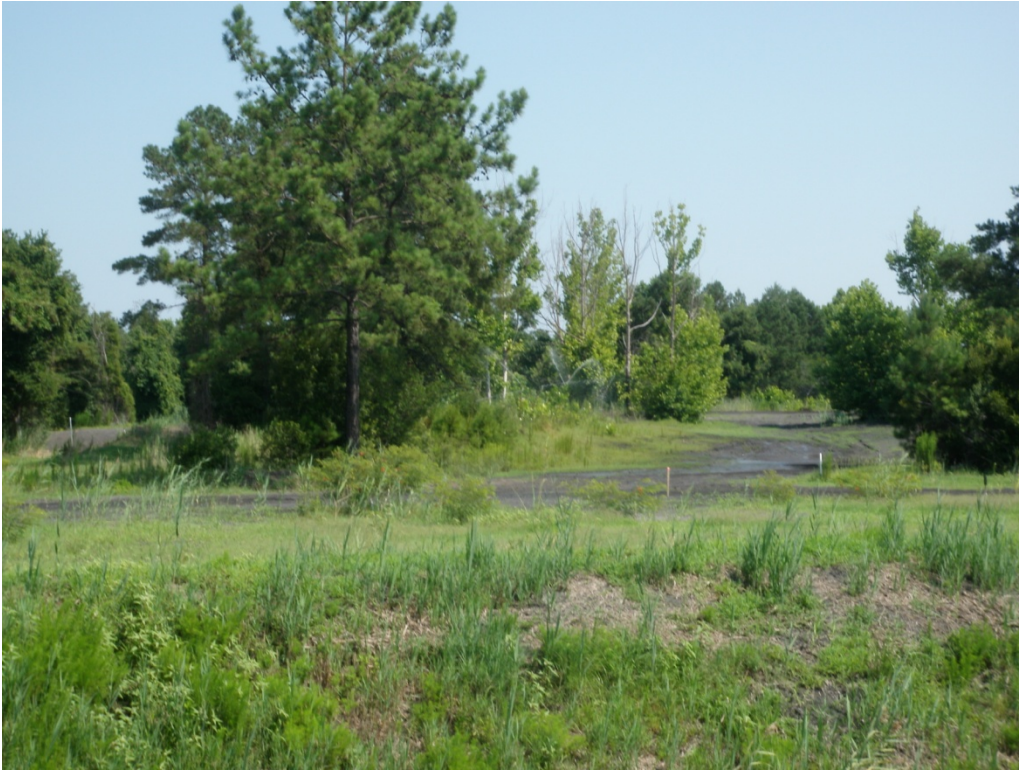
The ground surface within Ash Pond #1 was dry at the time of our visit, and trees are growing in the area. We observed the piles of dry CCW that have been placed in the impoundment. The CCW is sprayed with water to reduce dust. A network of drainage ditches has been constructed within the impoundment to drain stormwater and excess water from the dry CCW. The water collected in the impoundment is pumped to Ash Pond #2. We observed water flowing in the drainage ditches, and the system appeared to be functioning properly.

Photo 3 – Ash Pond #1: Dry ash handling area – note sprinklers to reduce dust.

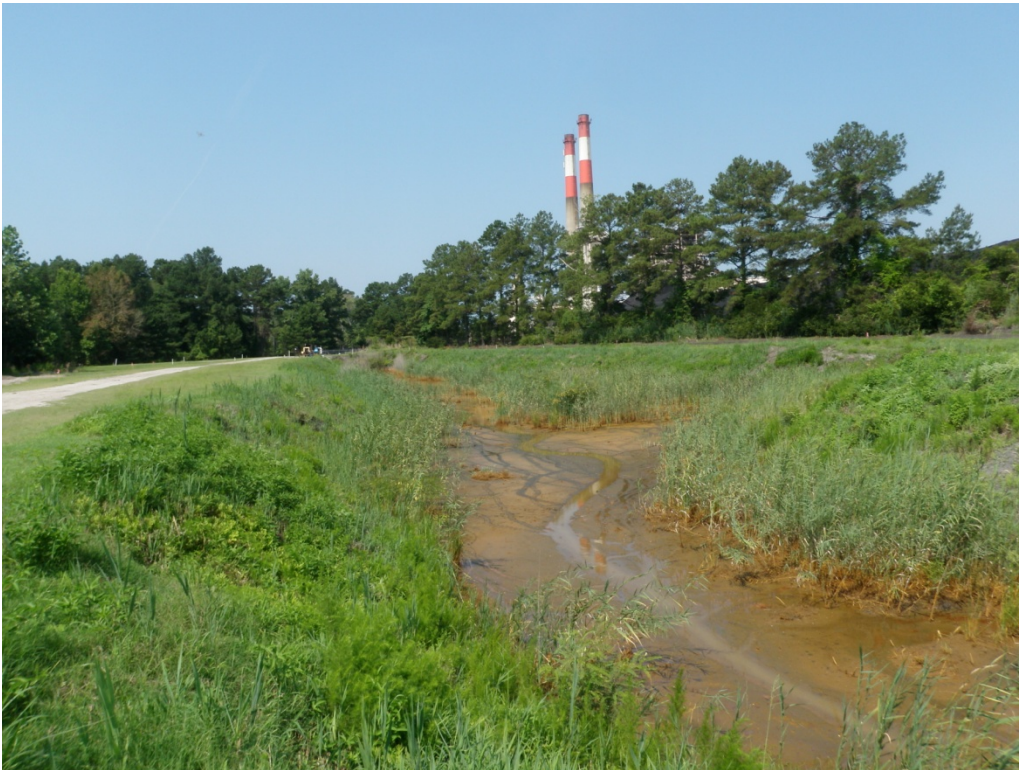
Photo 4 – Ash Pond #1: Dewatering channel.

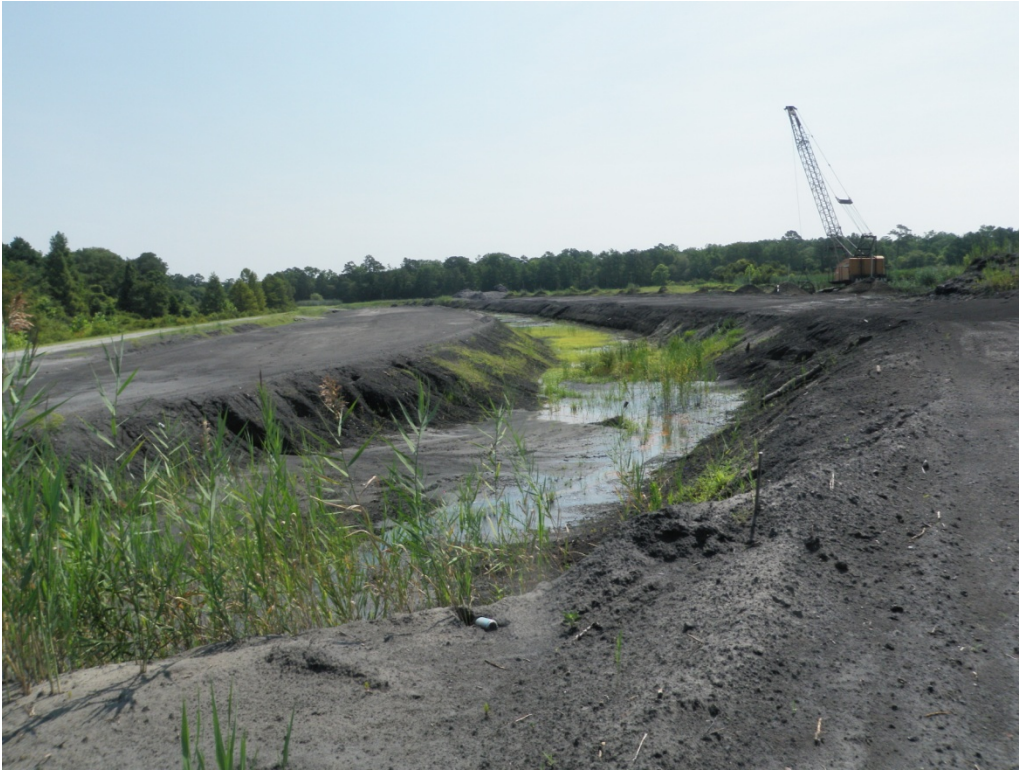
Photo 5 – Ash Pond #2: Primary ash slurry channel – dewatered and not in use during site visit.

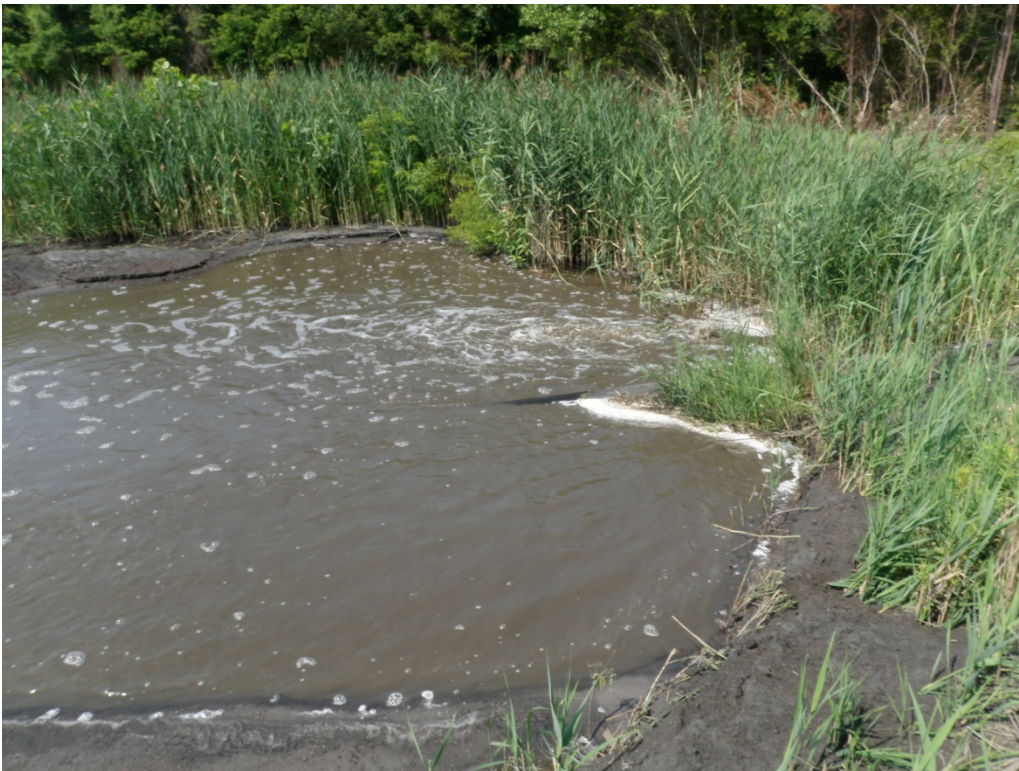
Photo 6 – Ash Pond #2: Ash slurry inflow.

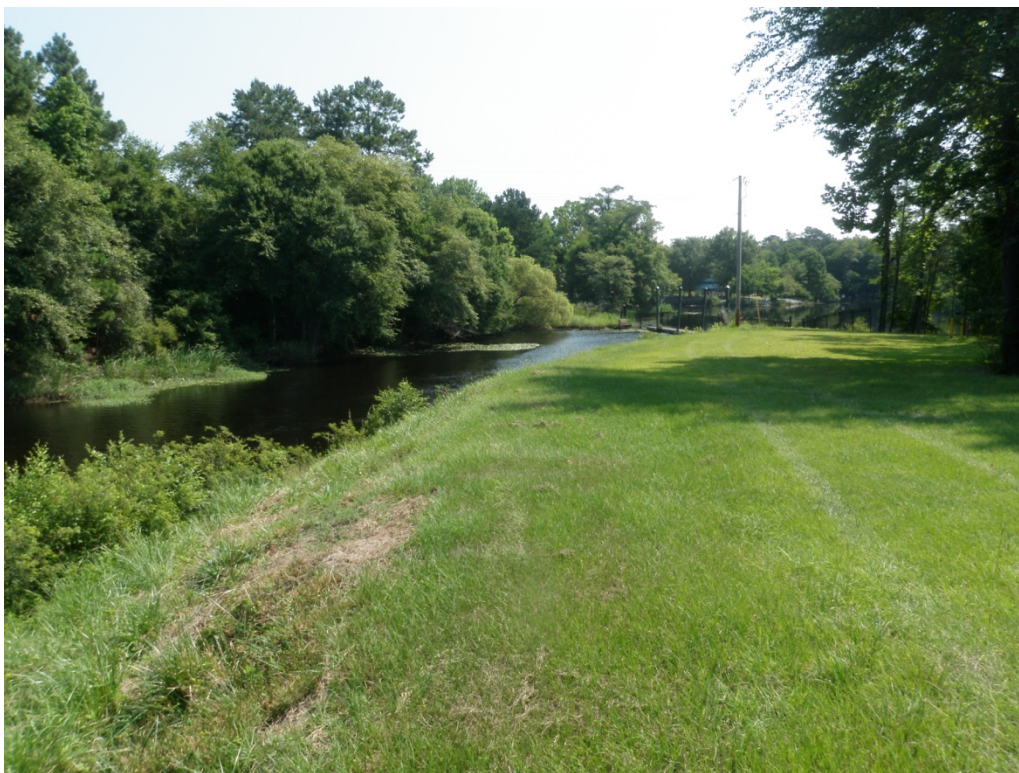
The downstream slopes of the dike at Ash Pond #2 have well-established grass growth, which provides some erosion protection. Large trees are present immediately downstream of the toe. These should be monitored to ensure that they do not encroach upon the dike slope, but in our opinion they are not currently a threat to the stability of the dike. No scarps, sloughs, depressions or other indications of slope instability or signs of erosion were observed during the inspection of the CCW impoundment.

Photo 7 – Ash Pond #2: Downstream slope, intake channel on left.

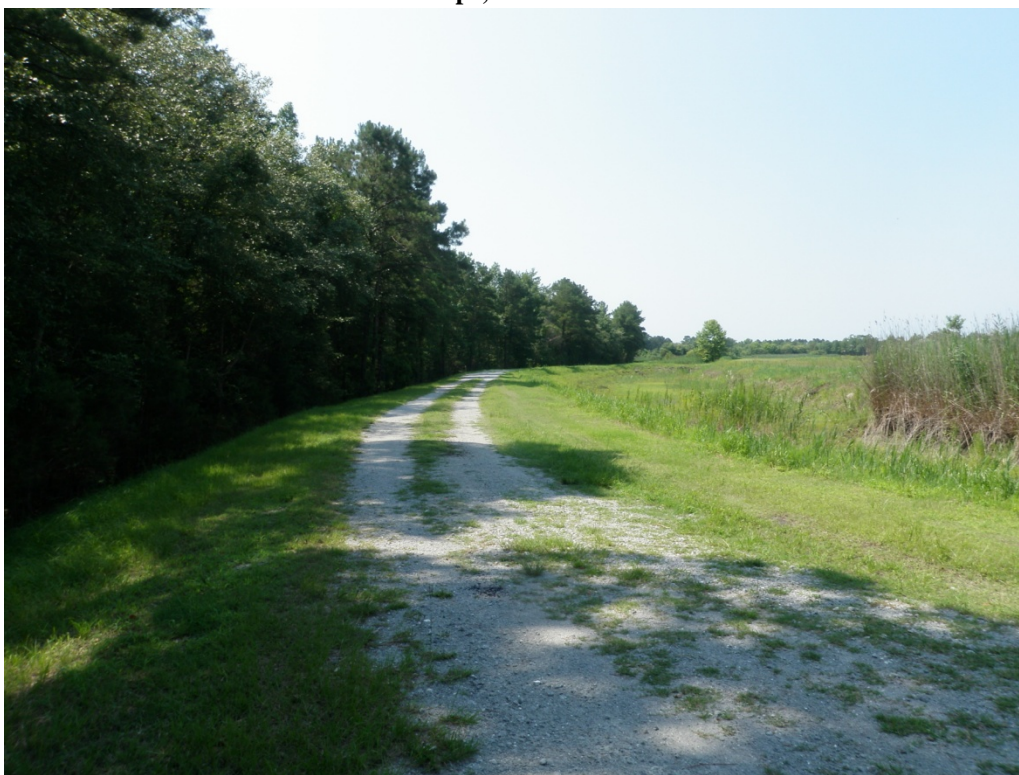
The 1990 stability analysis recommended that riprap be placed on the upstream slope in the area near the intake canal where the slope was oversteepened to 1.7H:1V, in order to increase the factor of safety and prevent future sloughing. Santee Cooper personnel indicated that riprap was not placed in this area, but that when the dike was raised, the sloughing was repaired and the slope was flattened. We did not observe sloughing or other signs of instability in this area during our field investigation.

Photo 8 – Ash Pond #2: Crest near intake channel.

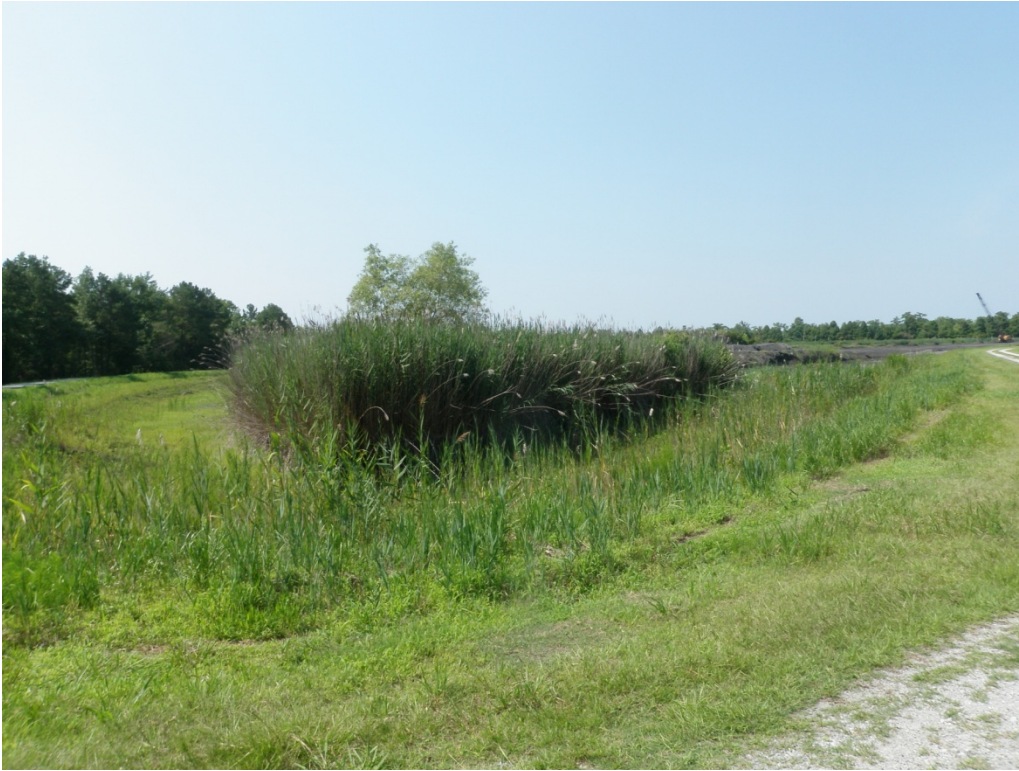
Photo 9 – Ash Pond #2: Overview.

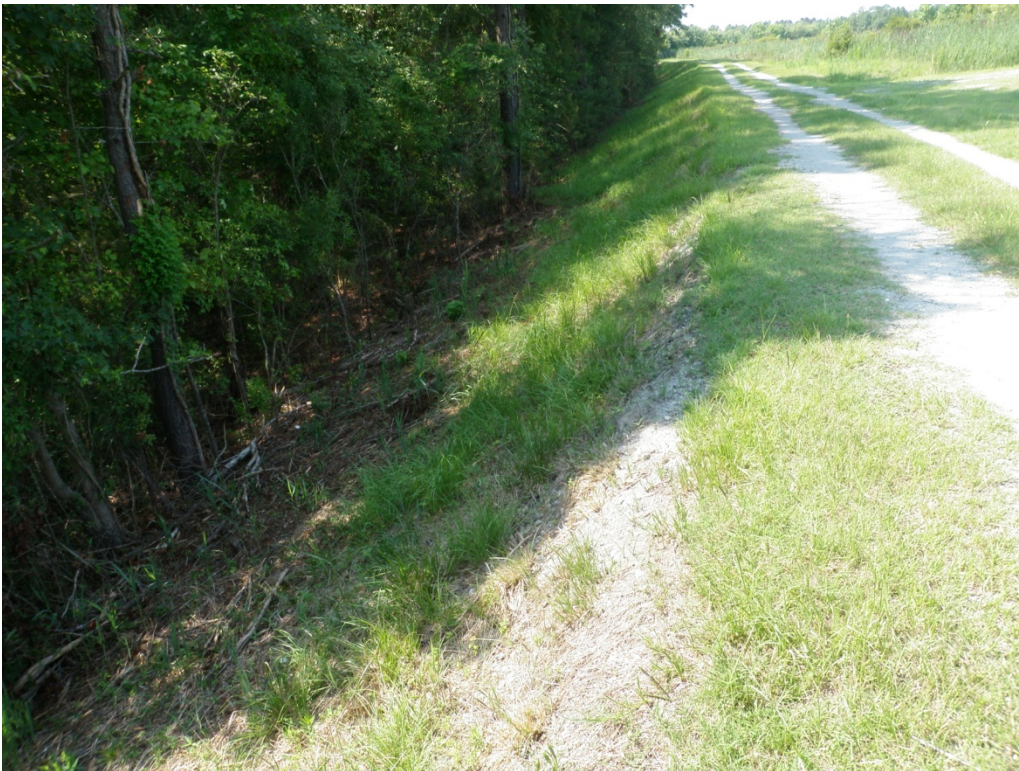
Photo 10 – Ash Pond #2: Downstream slope.

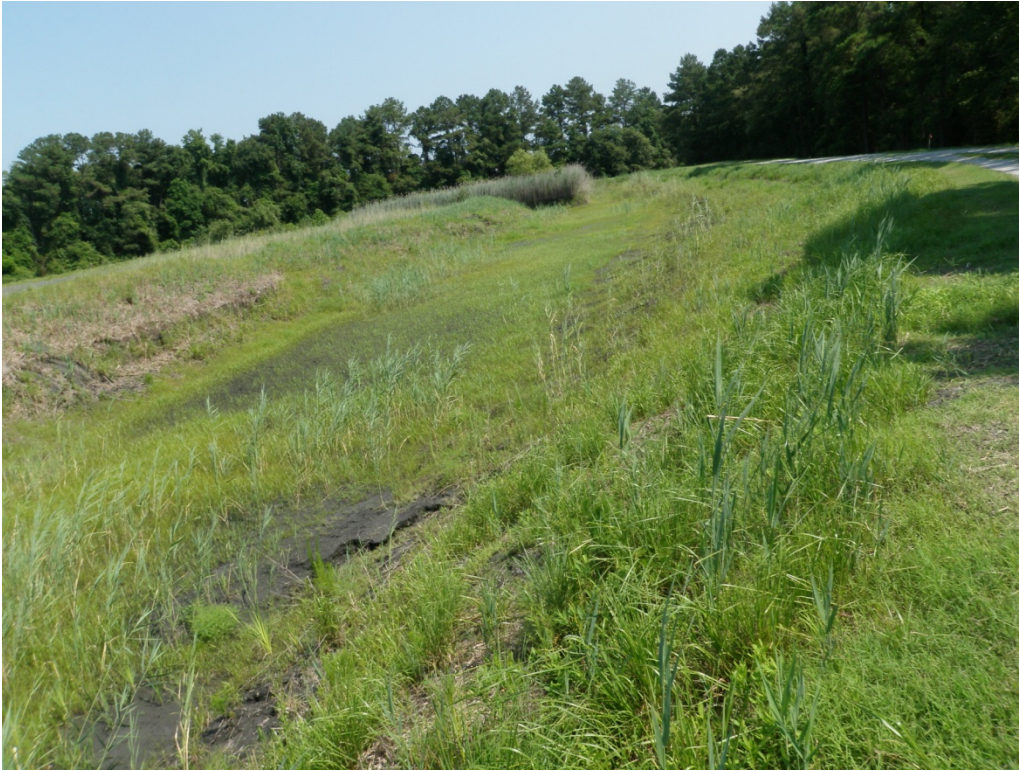
The upstream slopes of the dike at Ash Pond #2 have well-established grass growth. Riprap is present along the upstream slope where it is necessary for wave protection. The upstream slope protection appeared to be in good condition. No scarps, sloughs, depressions or other indications of slope instability or signs of erosion were observed during the inspection of the CCW impoundment.

Photo 11 – Ash Pond #2: Upstream slope.

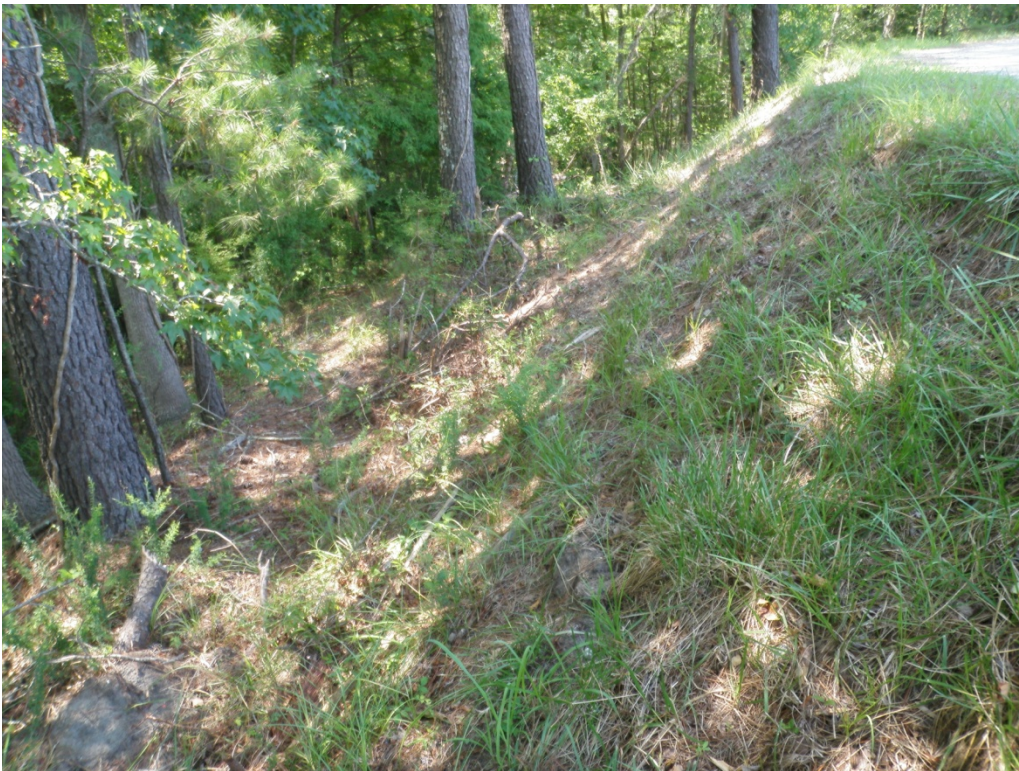
Photo 12 –Ash Pond #2: Downstream slope.

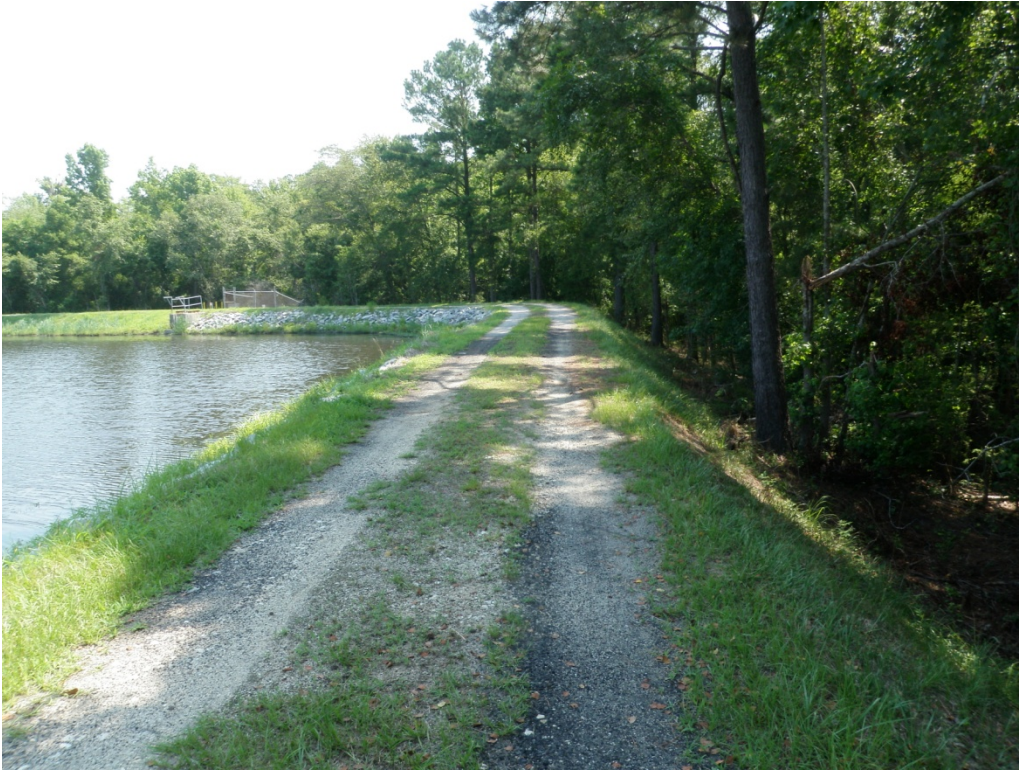
The crest of the dike at Ash Pond #2 appeared to be in good condition. No signs of cracking, settlement, movement, erosion or deterioration were observed during the assessment. The crest appears to be well-drained and no standing water was observed. The dike crest surface is generally composed of gravel road base material that traverses the length of the dike for vehicle access.

Photo 13 –Ash Pond #2: Crest.

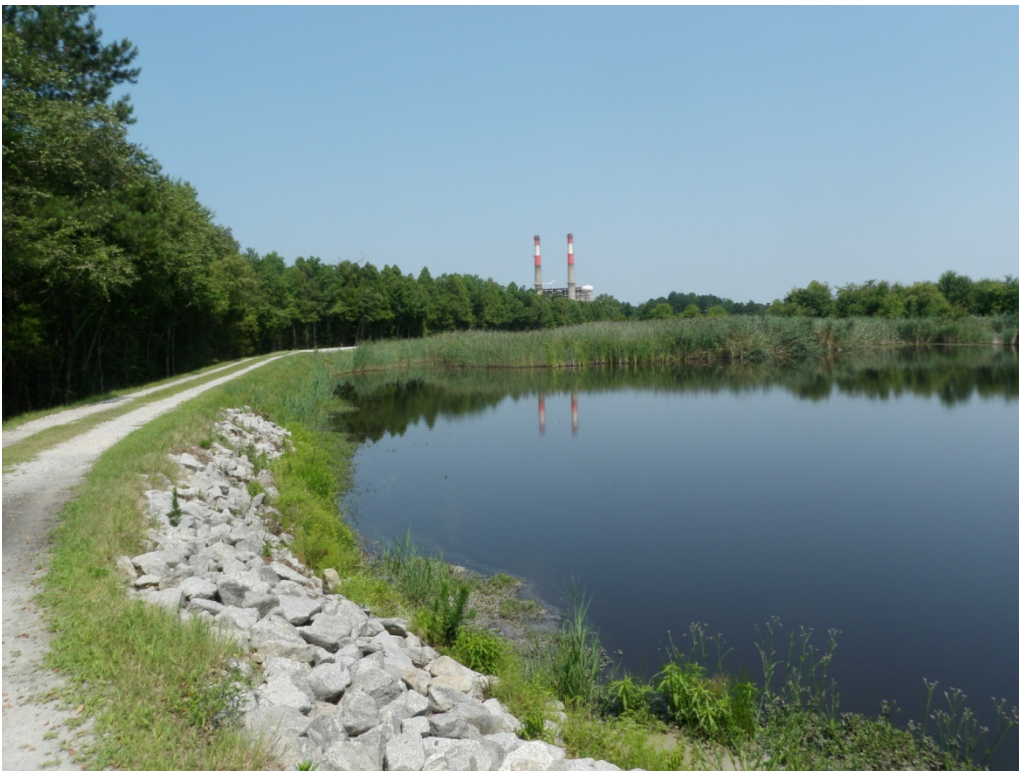
Photo 14 – Ash Pond #2: Upstream slope. Note riprap slope protection.

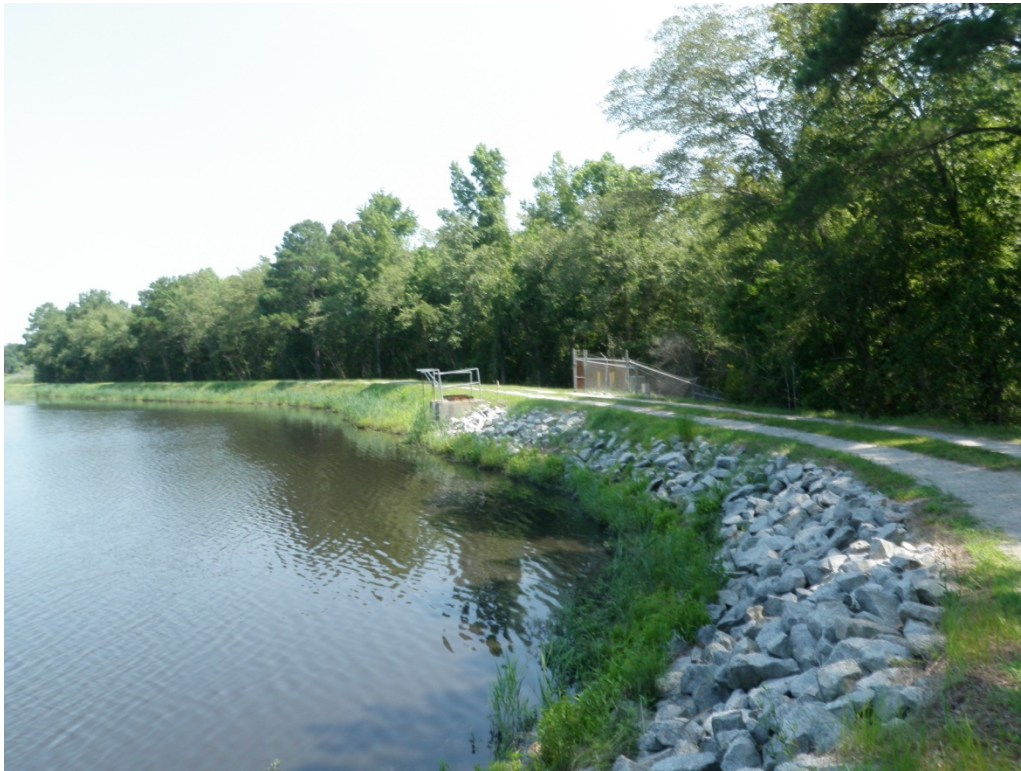
The outlet structure located in Ash Pond #2 appeared to be in good condition. The structure was observed to be working properly, discharging decant water downstream. Stop logs used to control the flow appeared to be functional, and a trashrack was in place. The outlet conduit consists of 12-inch reinforced concrete pipe (RCP) and appears to be in good condition. The Parshall Flume used to monitor flow appeared to be functional and readable. Riprap in the outlet channel was also in good condition.

Photo 15: Ash Pond #2: Outlet works and upstream slope.

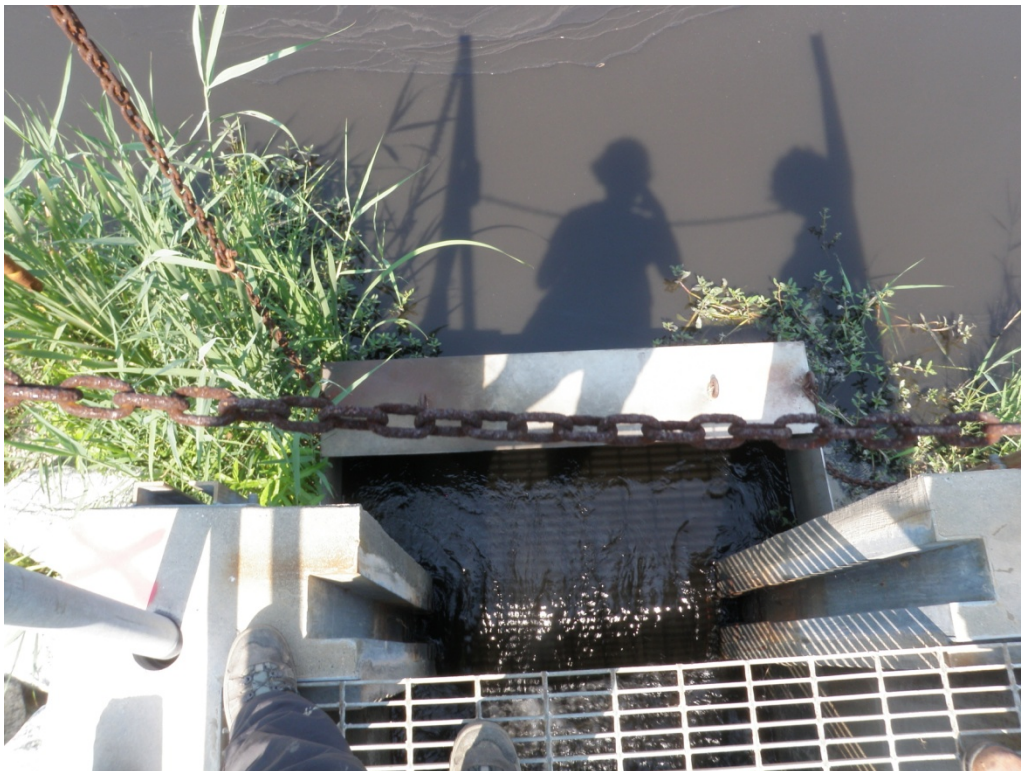
Photo 16 – Ash Pond #2: Decant inlet.

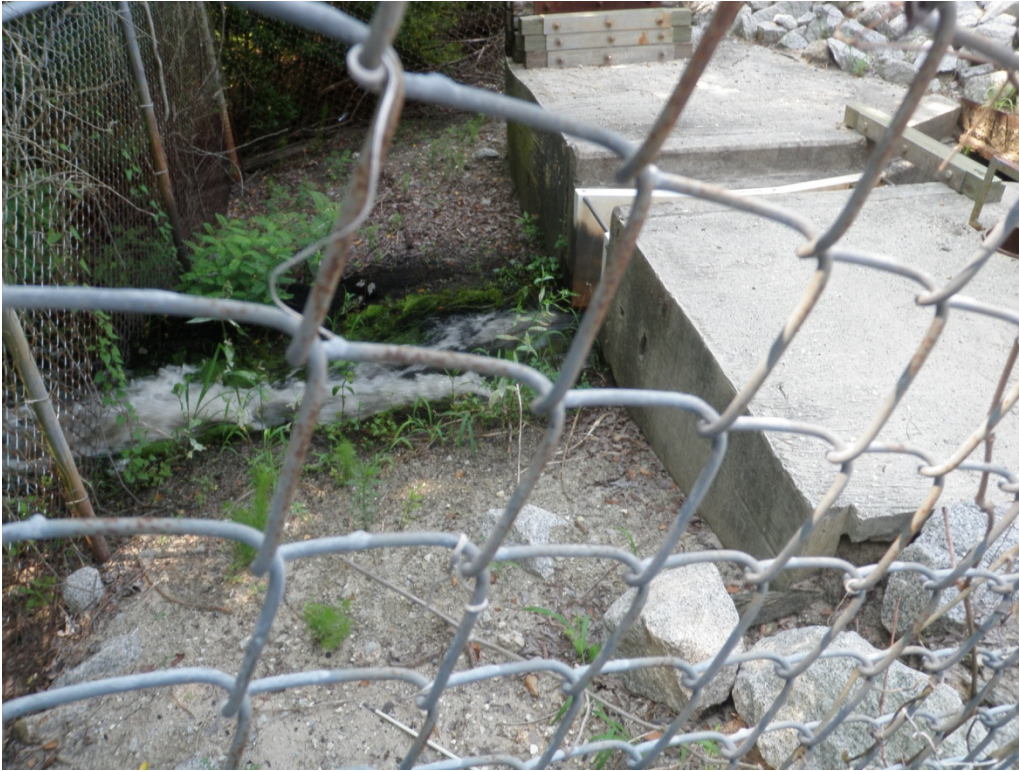
Photo 17: Ash Pond #2: Outlet structure with Parshall Flume.

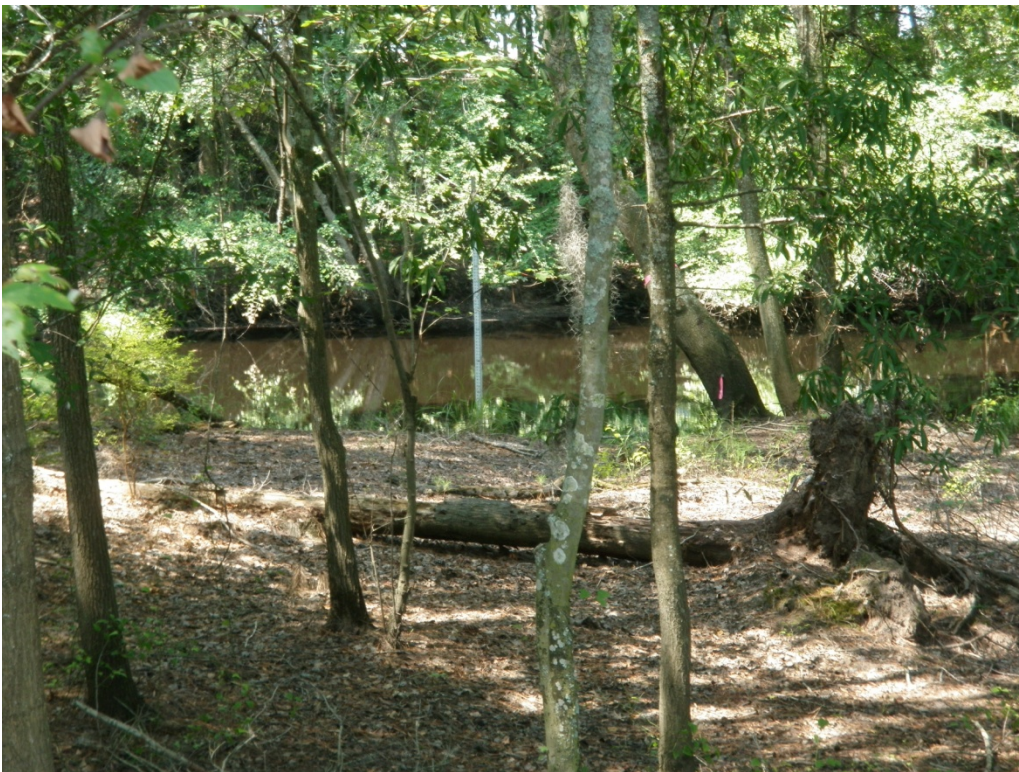
Photo 18: Ash Pond #2: Staff gauge at highway drainage ditch west of pond.

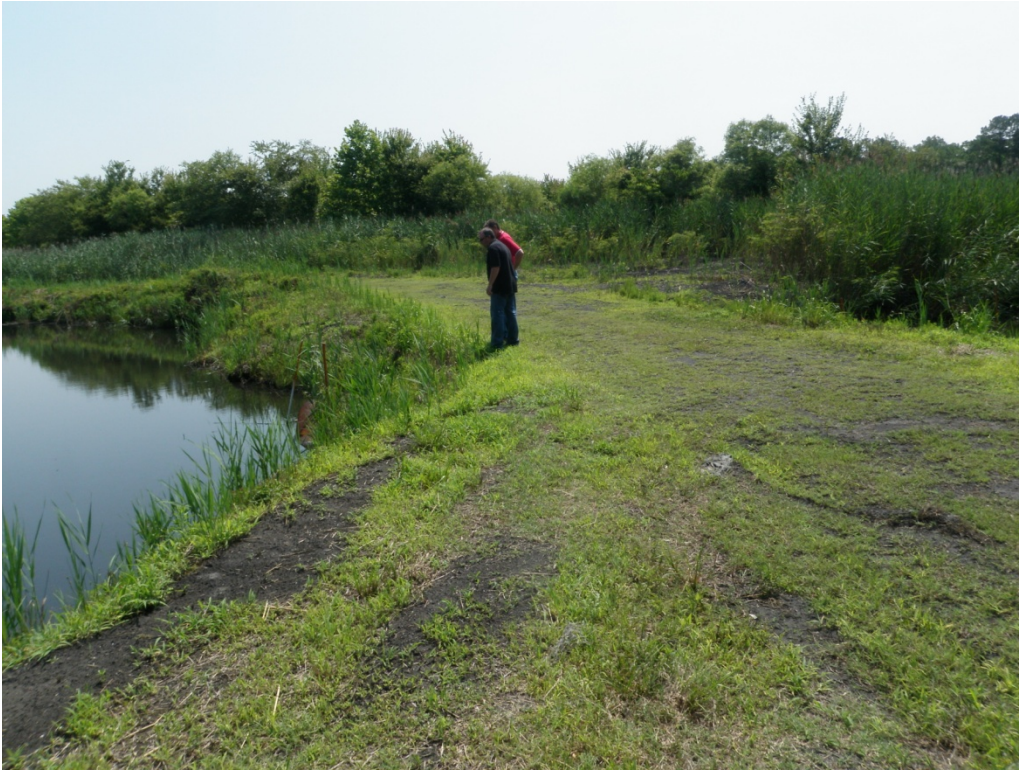
Photo 19 – Ash Pond #2: Divider fill between east and west cells.

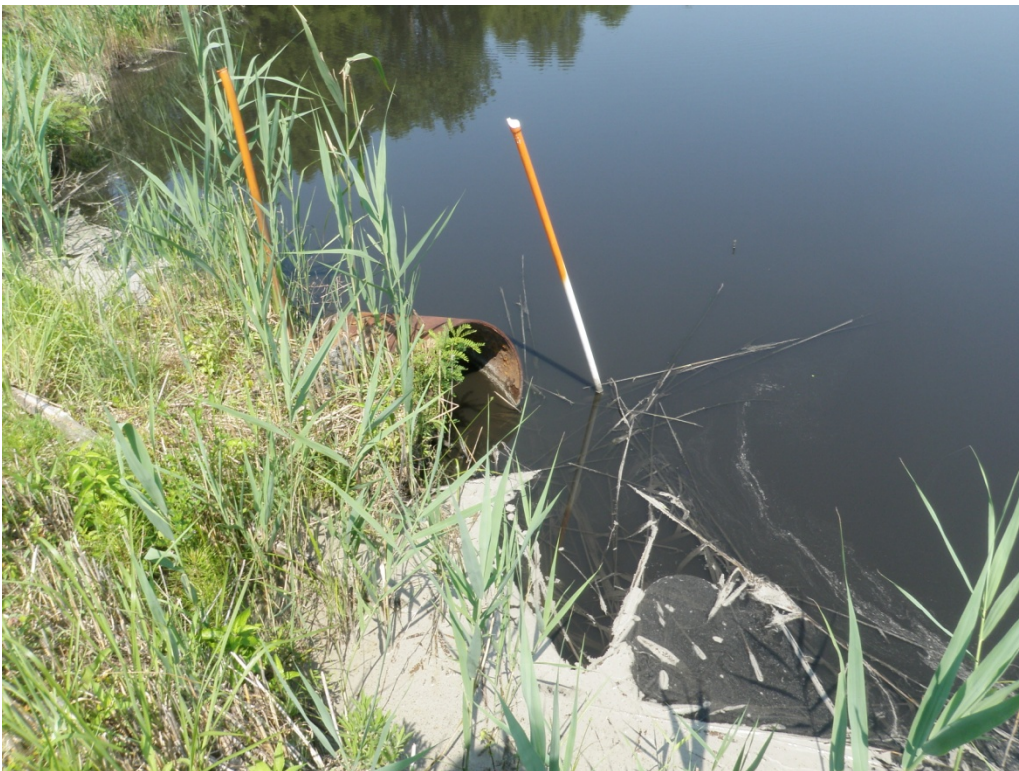
Photo 20 – Ash Pond #2: Decant pipe between cells – west cell inlet.

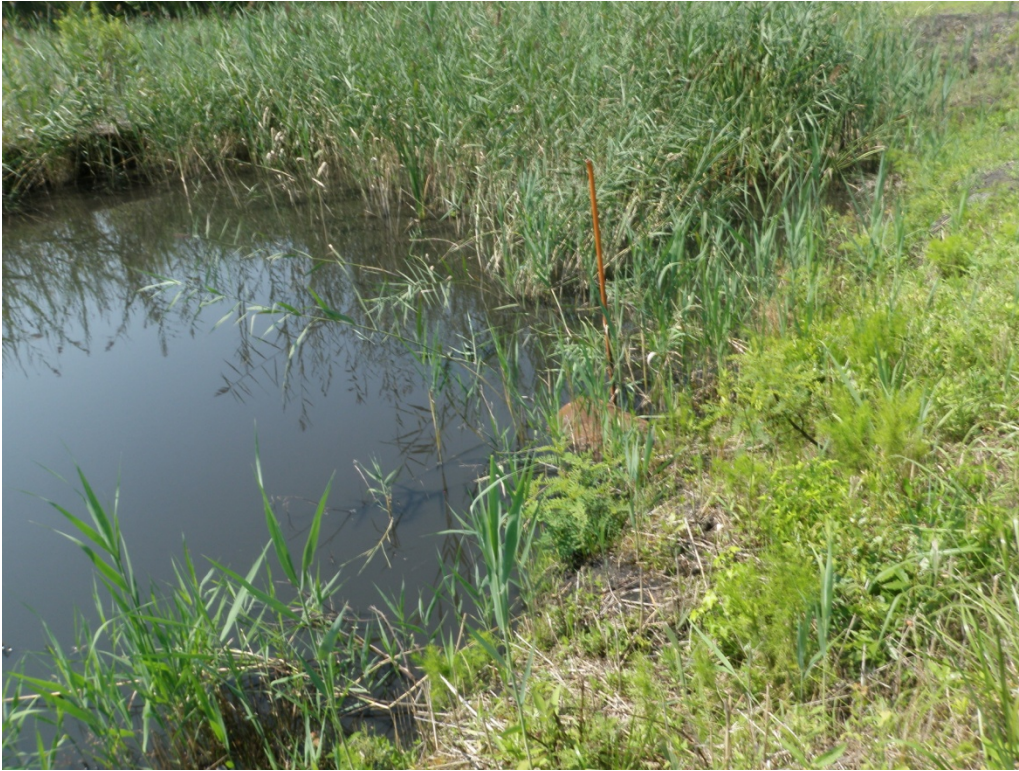
Photo 21 – Ash Pond #2: Decant pipe between cells – east cell outlet.

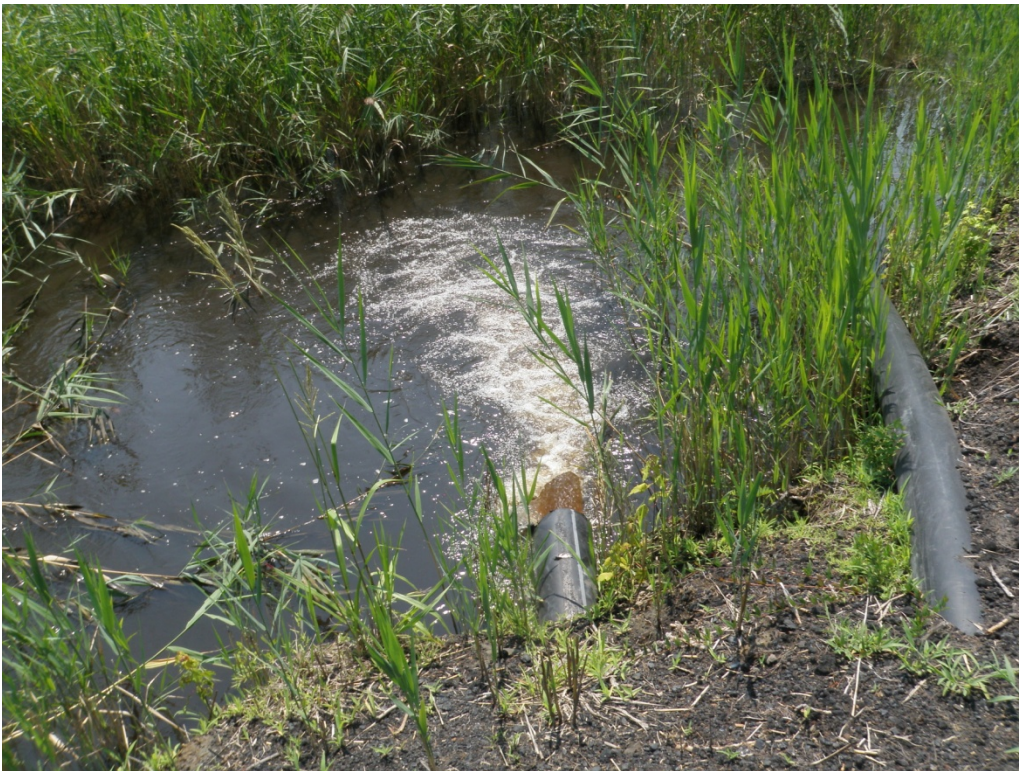
Photo 22 – Ash Pond #2: Wastewater discharge into east cell.
